# AIR FORCE TEST CENTER

TECHNICAL REPORT  
NO. OTTC 5547

INVESTIGATION OF ENGINE OPERATIONAL  
DEFICIENCIES IN THE  
F-86 AIRPLANE

INVESTIGATION OF ENGINE OPERATIONAL DEFICIENCIES  
IN THE F-86E AIRPLANE

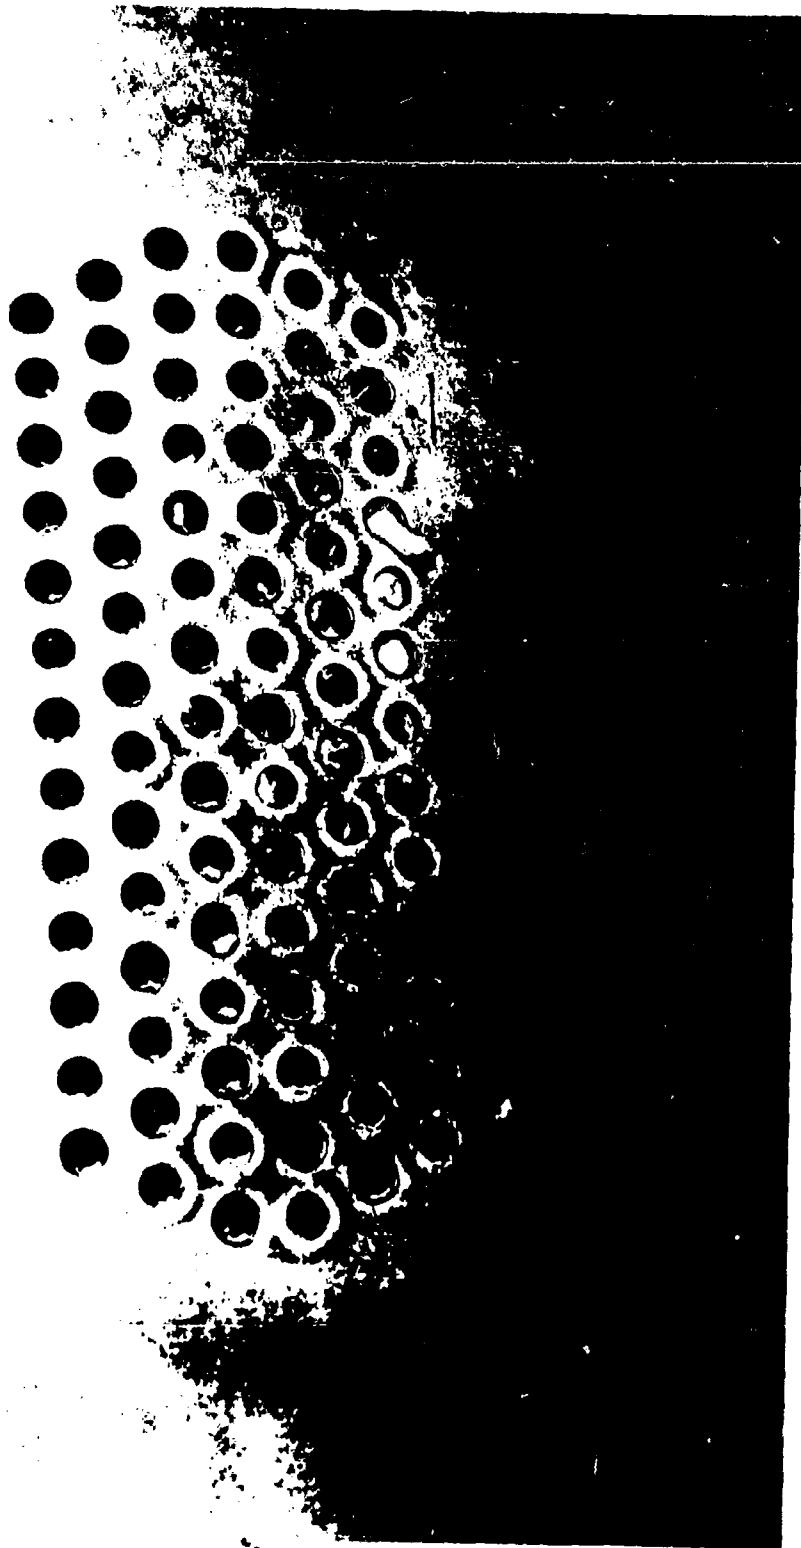
b. When the engine was shut down after an initial ten-minute ground run, a large quantity of smoke emerged from the combustion chamber area. It was noticed that molten metal had accumulated in the vent holes on each side of the turbine frame. The engine was removed from the airplane for further inspection and it was found that a portion of the No. 4 bearing air-oil seal had

melted away and the bearing rollers and race bore a number of bright longitudinal streaks. (These discrepancies are illustrated in Figures 1 through 3.) The turbine frame section had to be replaced since it was contaminated with metal particles. The aft oil system was flushed. Upon removal of the combustion chambers it was discovered that the inner cross-fire tubes between the No. 2 and No. 3 combustion chambers were missing. The discrepancies were corrected and the engine was reassembled and run in the test cell. Compressor stalls were encountered on burst accelerations from 70% and 50% engine speeds. Oil consumption was approximately  $\frac{1}{2}$  pounds per hour.

Fig. 1  
MOLTEN SPAL METAL IN TEST HOLES, J47-13 ENG. S/N 042764

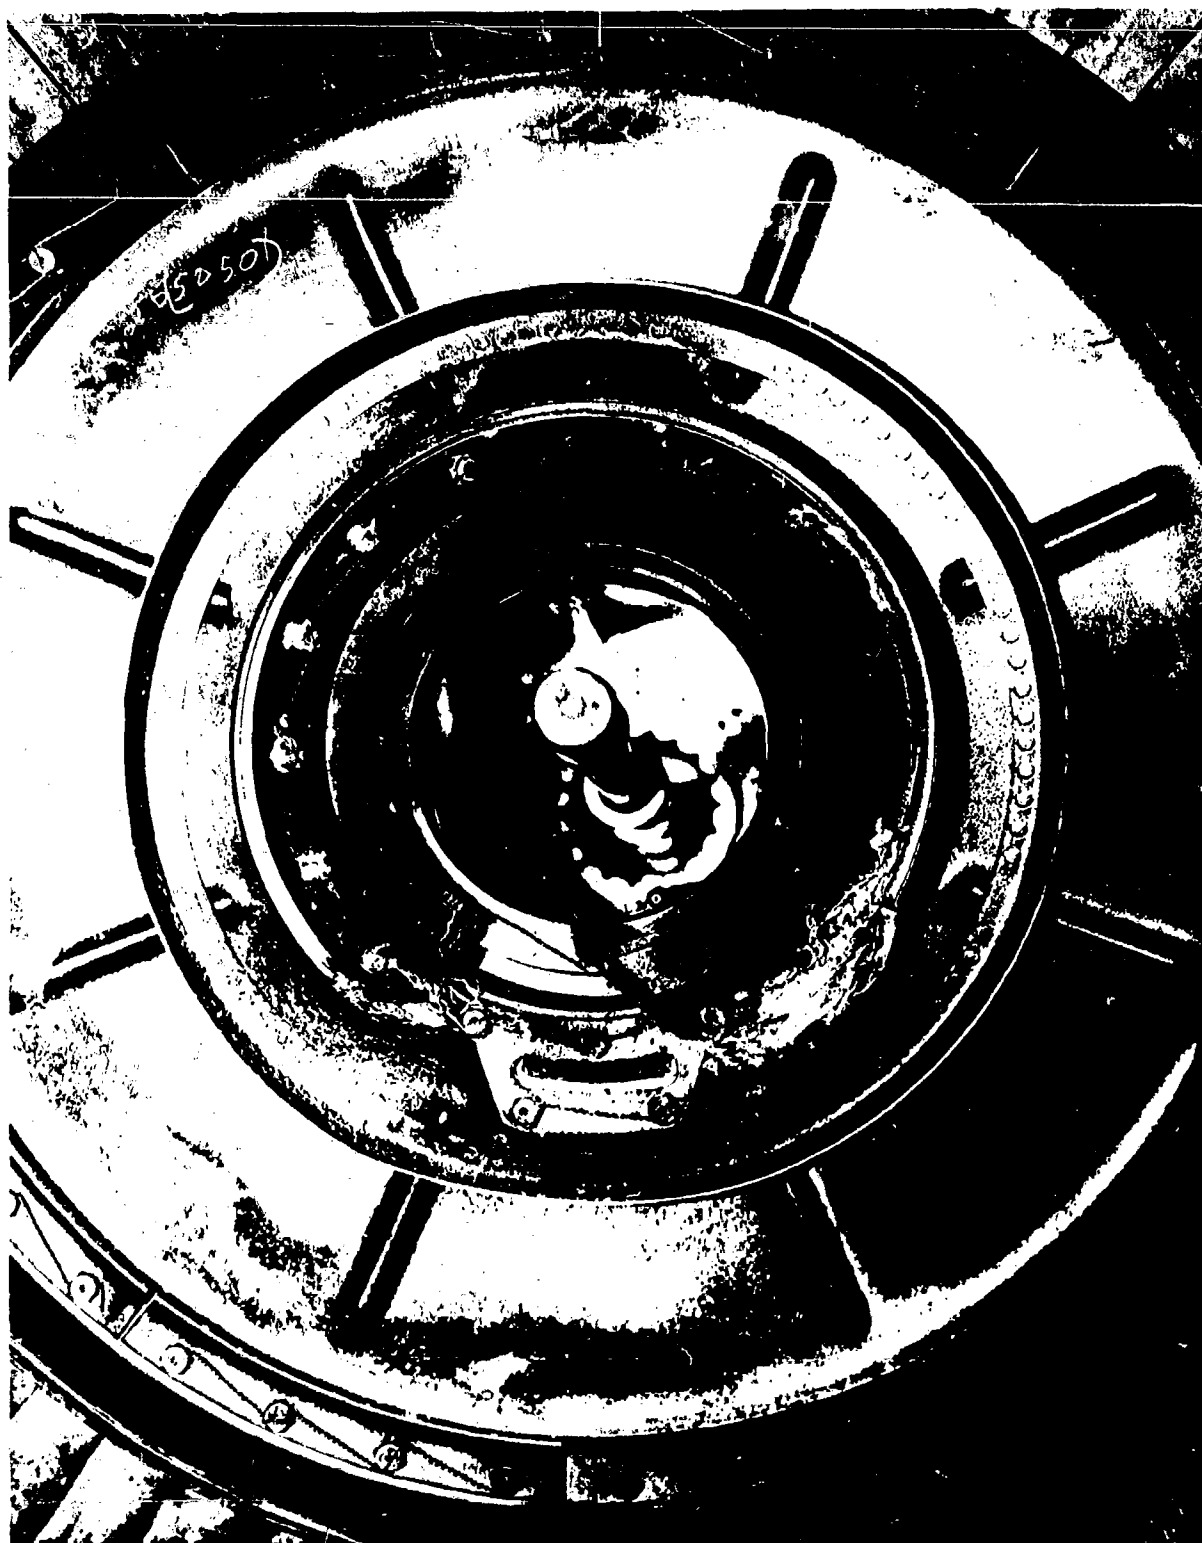
FIG. 2

MELTED NO. 4 BEARING AIR SEAL, J47-15 ENG. S/N 042764

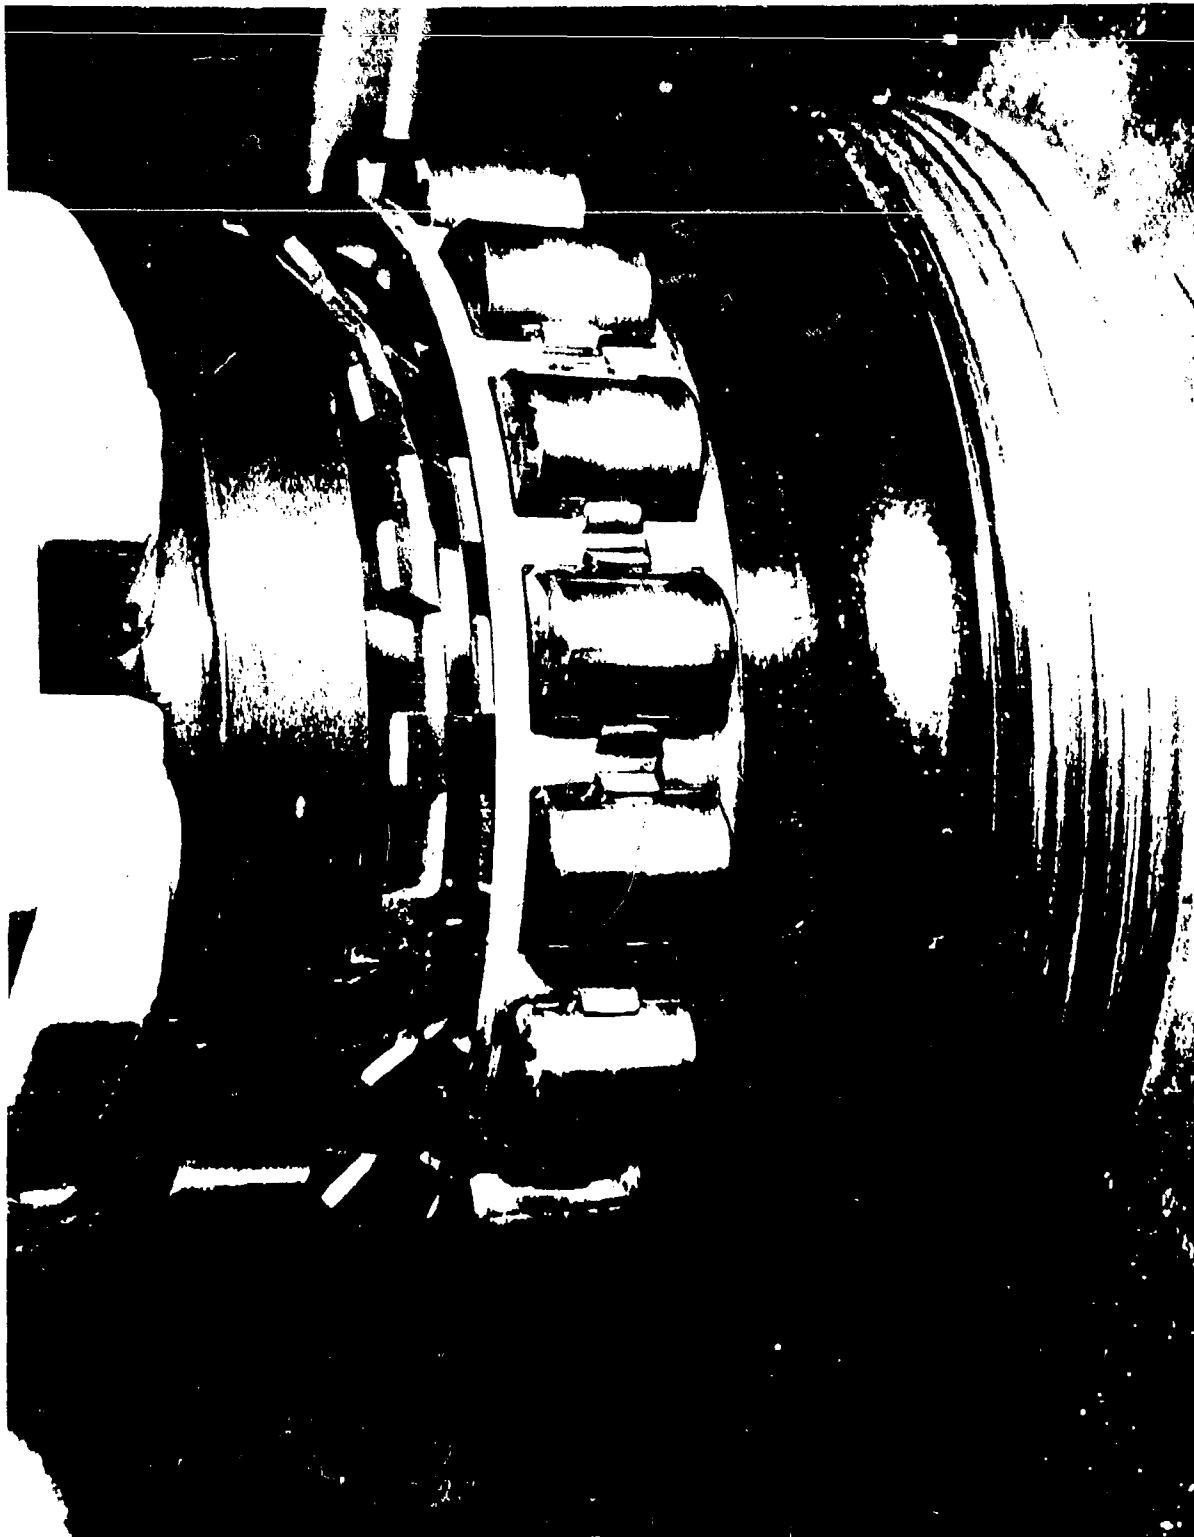
FIG. 3  
ENGINE NO. 4 READING, J47-16 ENG. S/N 042709

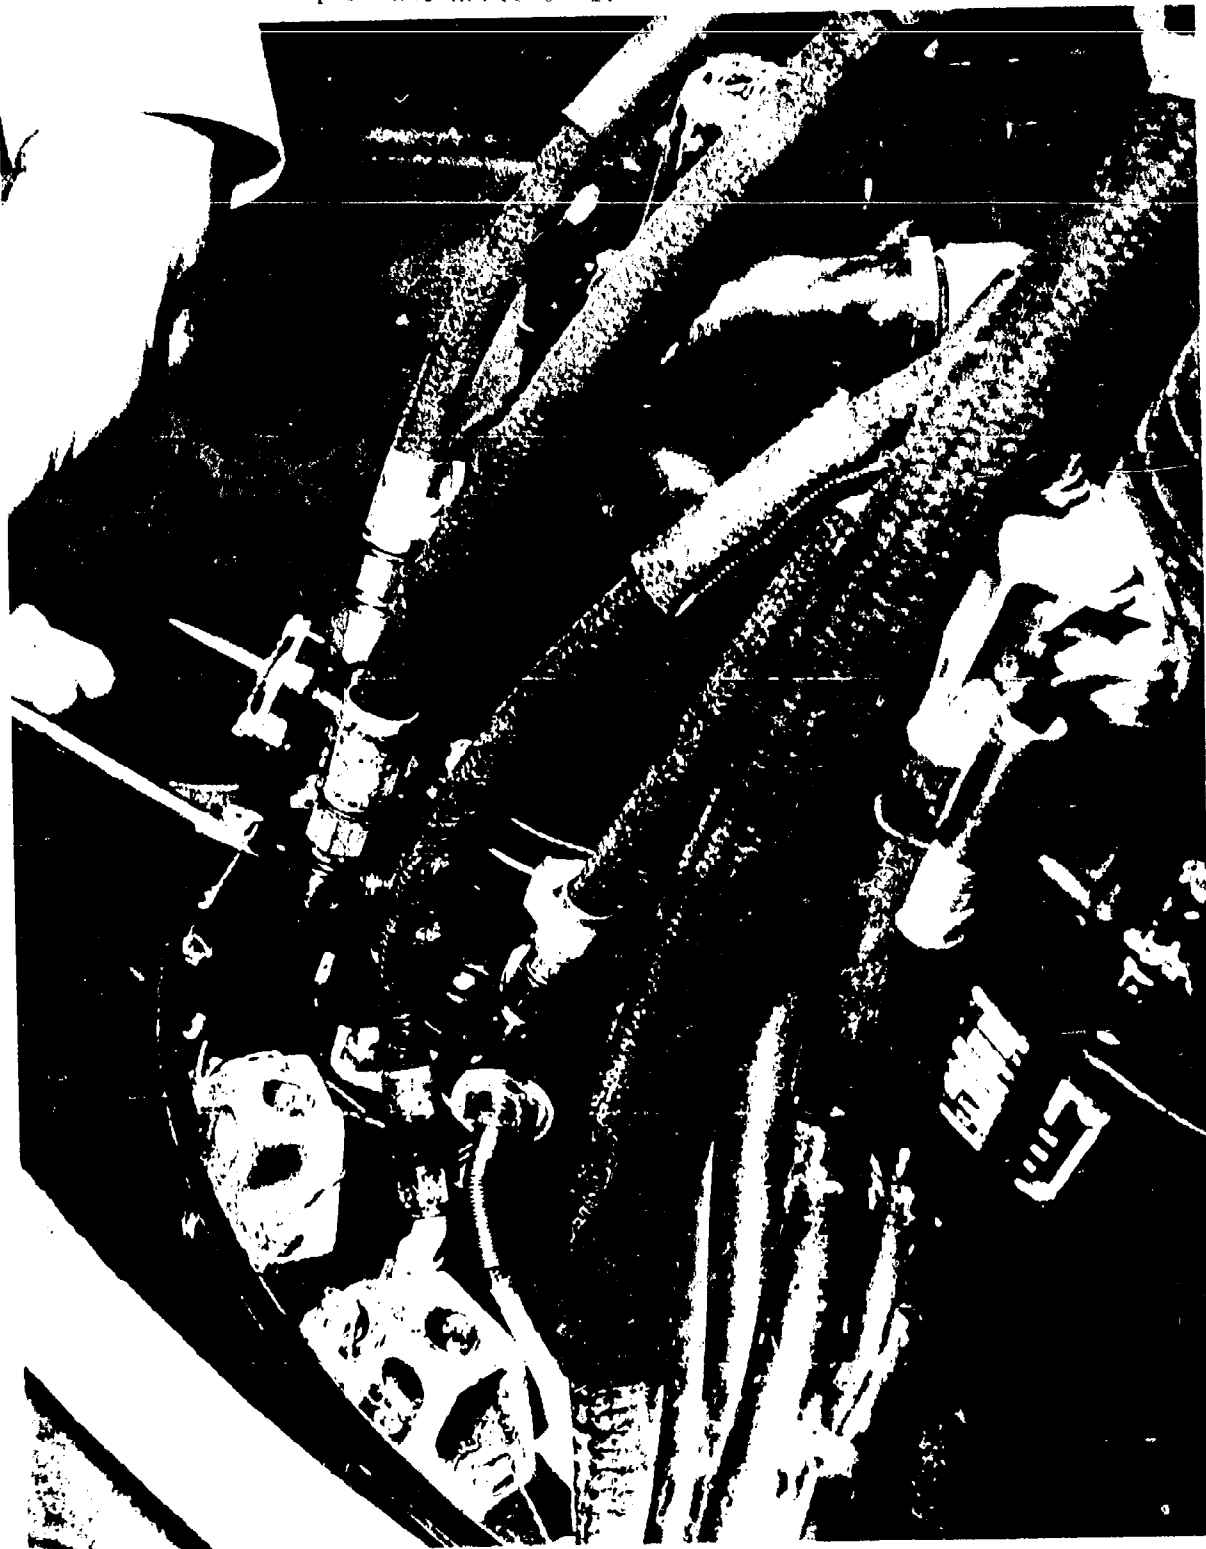
FIG. 4

b. The complete loss of oil pressure suggested the probability that the oil tank was being emptied, causing the lube pump to pump air into the fuel regulator. It was suspected that this caused a drop in regulator output pressure which resulted in a corresponding drop in fuel pressure and engine speed. A mock-up of the system was tested on the flow bench to corroborate this theory. It was found that the regulator was not affected by shutting off the inlet oil, but injection of air into the oil inlet line caused a drop in regulator output pressure. A study of the regulator showed that the control oil pump in the regulator normally draws oil directly from the inlet line. By changing the oil inlet to the port (normally unused) directly above the V.C.O. port, any air pumped into the regulator case was allowed to escape through the adjacent oil return port on top of the regulator case. The regulator then continued to operate normally on its case oil supply. There was the possibility that this configuration might not afford sufficient changing of the oil to prevent overheating of the regulator, but this was found to be no problem. Figure 4 illustrates the modification.

RELOCATED OIL INLET LINE TO FUEL REGULATOR

8. It was recommended that the fuel regulator plumbing change be incorporated on F-86E engines to prevent erratic fuel regulation or power loss caused by depletion of the oil supply. Steps have been taken to effect this change.

c. To incorporate the regulator plumbing change on the engine it was necessary to remove one of the upper support channels from the power take-off ring assembly to provide clearance for the new line. A thermocouple was installed to measure the regulator oil temperature.

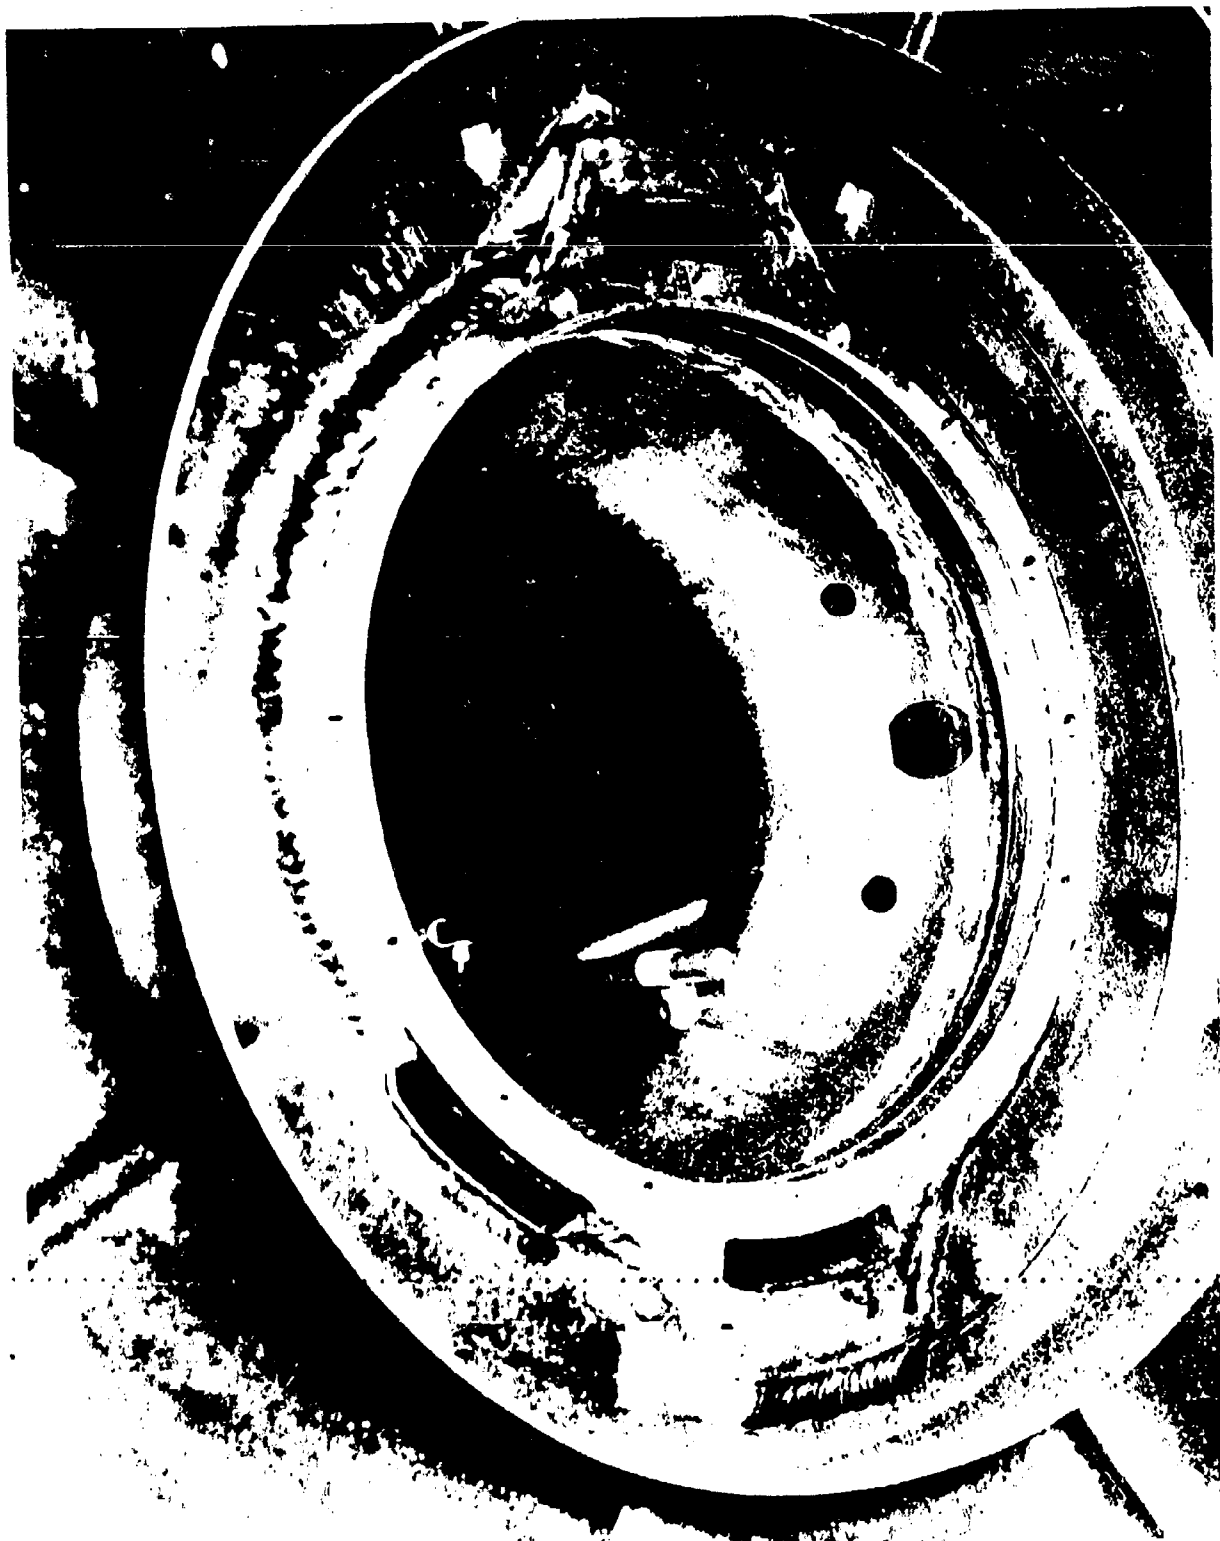
k. Inspection of the original turbine frame disclosed extensive cracks in the inner circumferential weld just forward of the No. 4 bearing housing (Ref. Fig. 5). Apparently, air flow through these cracks prevented the oil from reaching the aft scavenge pump inlet. During climbs, when most of the oil would normally flow toward the aft inlet this blocking effect at the aft inlet ultimately caused the oil tank to be emptied.

a. The power loss phenomenon was caused by air being pumped into the fuel regulator as a result of inadequate oil scavenging and the limited oil supply in the F-86E airplane. The cracked turbine frame was directly responsible for the poor oil scavenging.

Fig. 5  
CRACKED WELD IN TURBINE FRAME, J47-13 ENG. S/N 042042
